Success Story

Bright prospects: Hostaform® POM MetaLX™ with metallic look

Hostaform® POM MetaLX™ – components with integrated metallic look in one shot

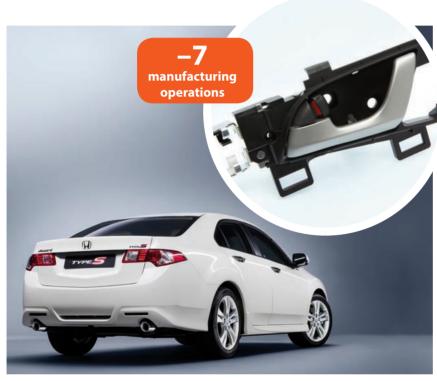
Hostaform® POM MetaLXTM makes a dazzling impression in the Honda Accord with classy metallic-look door handles.

- Cost-efficient production of components with integrated metallic look for vehicle interiors
- Door handles made from Hostaform® POM MetaLX™ on the Honda Accord
